Bushy Lake Draft Conceptual Restoration Plan

October 2023

BUSHY LAKE CONCEPTUAL RESTORATION PROJECT, SACRAMENTO, CALIFORNIA

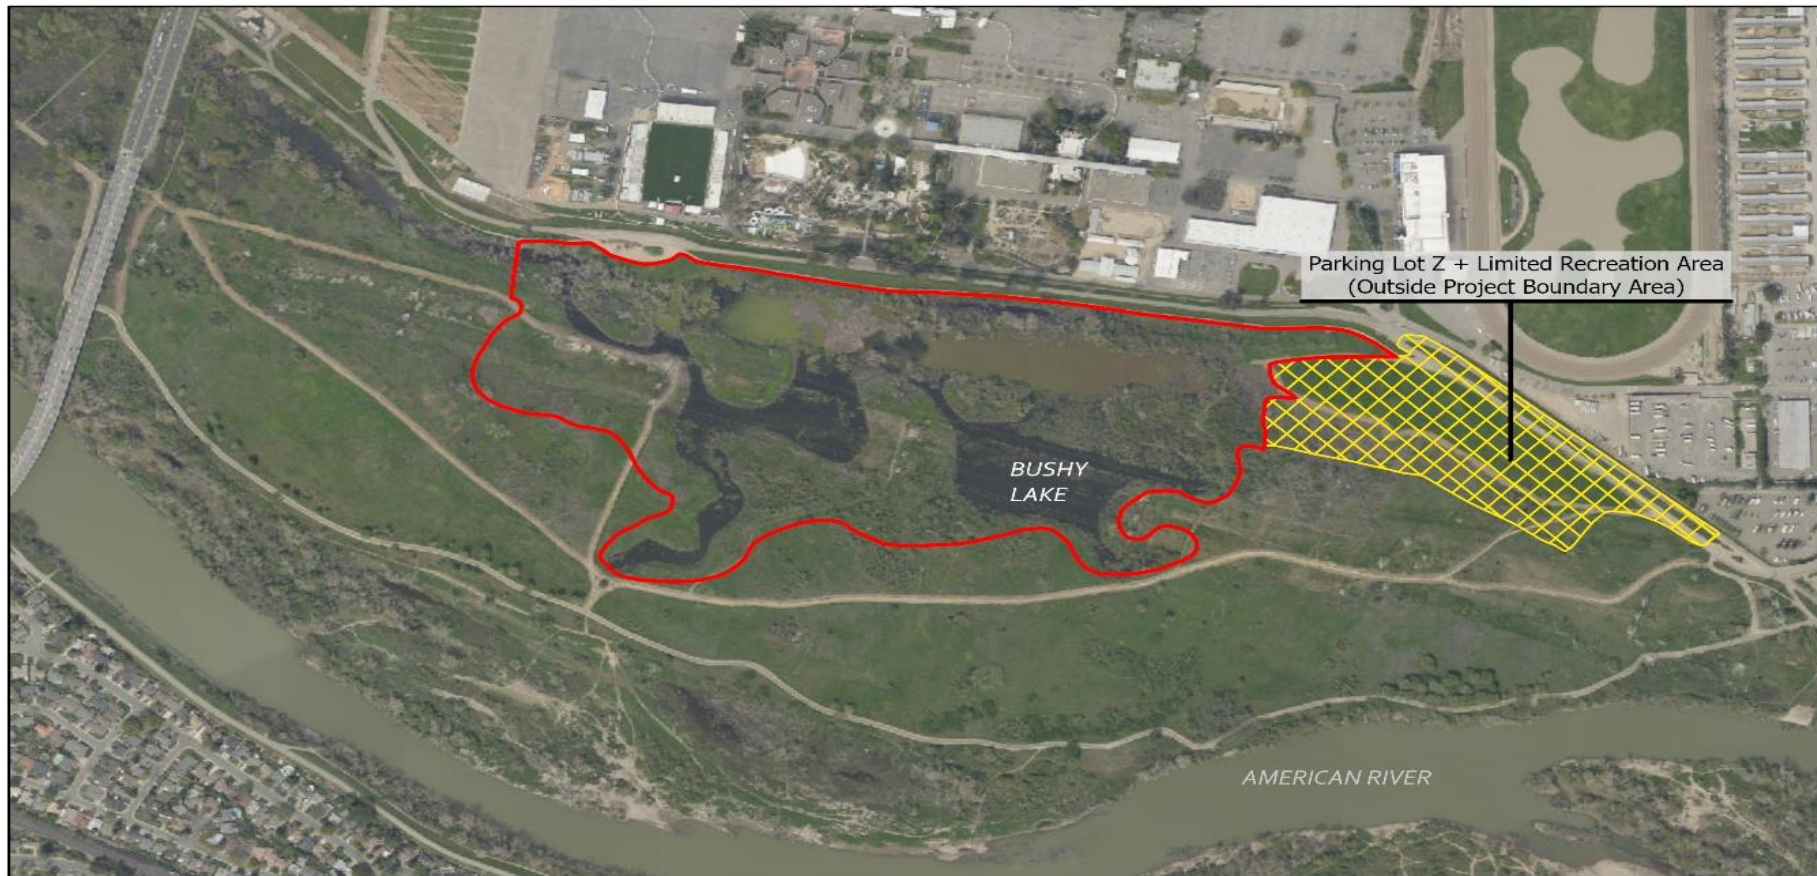
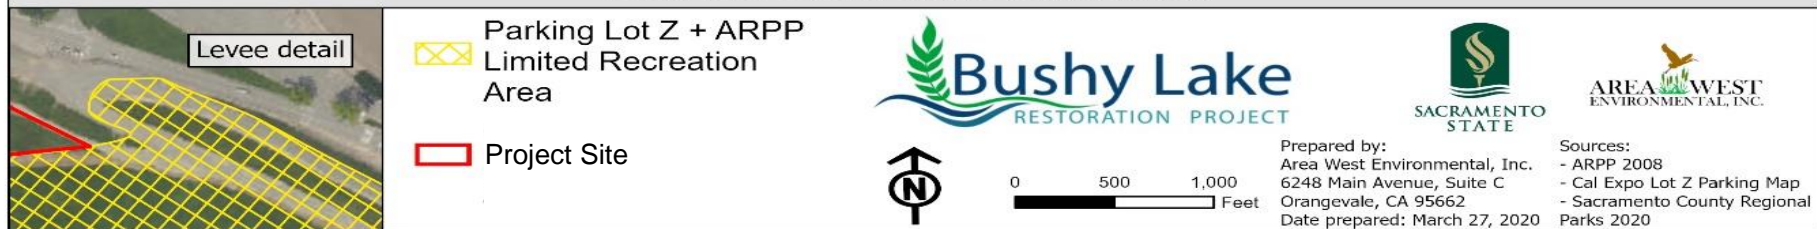
Figure 3. Bushy Lake Conceptual Restoration Planning Area

The developed areas north and south of the levees support dense residential and commercial uses. To the north of the proposed Bushy Lake Restoration Area is the levee and Cal Expo, to the south, east, and west is the floodplain of the American River, with the American River being located 1,100 feet south of the proposed restoration area. Immediately east of Bushy Lake, within the levees, is an 11-acre area used for overflow parking by Cal Expo during the State Fair, "Parking Lot Z" (Figure 3).

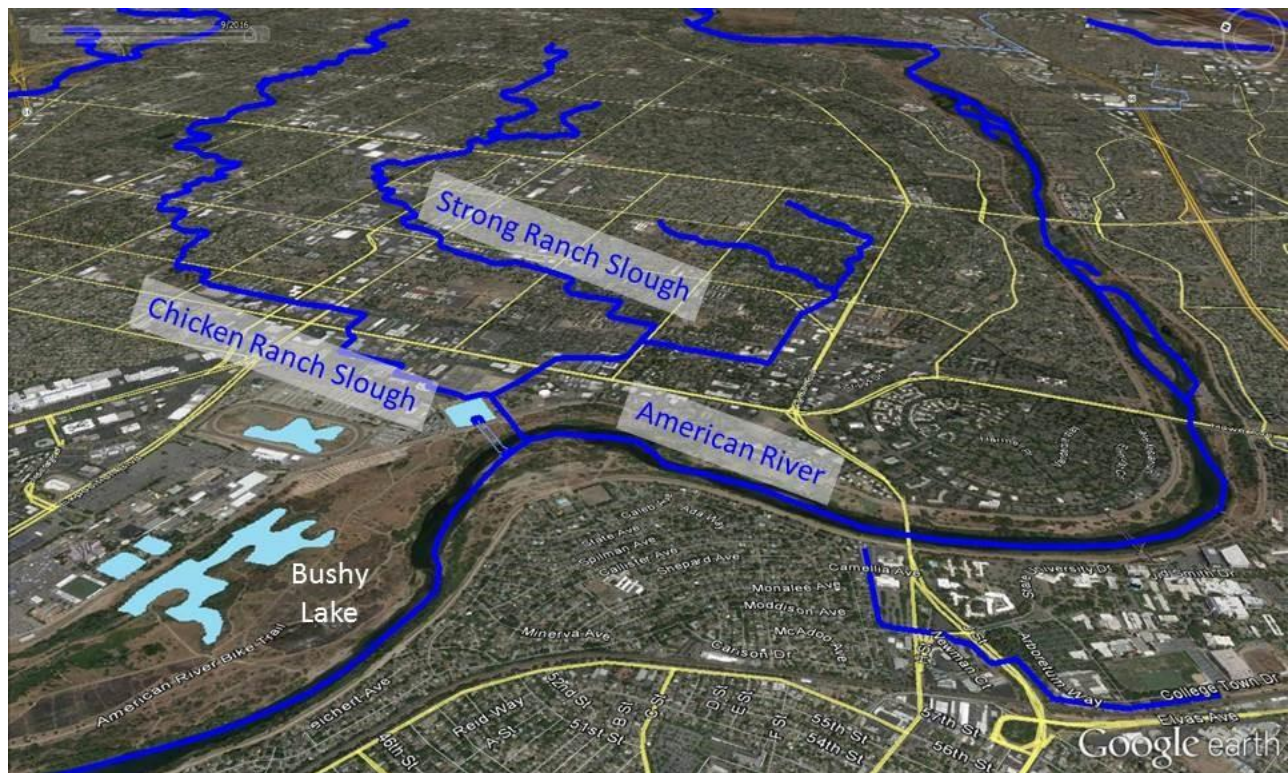
Figure 7. Bushy Lake area with Chicken Ranch and Strong Ranch Sloughs

Bushy Lake is located within the lower American River floodplain. Historically, the river channel would meander and shift within this floodplain (Castaneda and Simpson 2013). Seasonal creeks from the northeast, such as Chicken Ranch and Strong Ranch Sloughs, which pass through the Arden-Arcade area, once contributed to Bushy Lake water levels into the summer (Figure 7). Today, these creeks have been channelized and lined with concrete to collect storm water and convey it quickly into the American River.

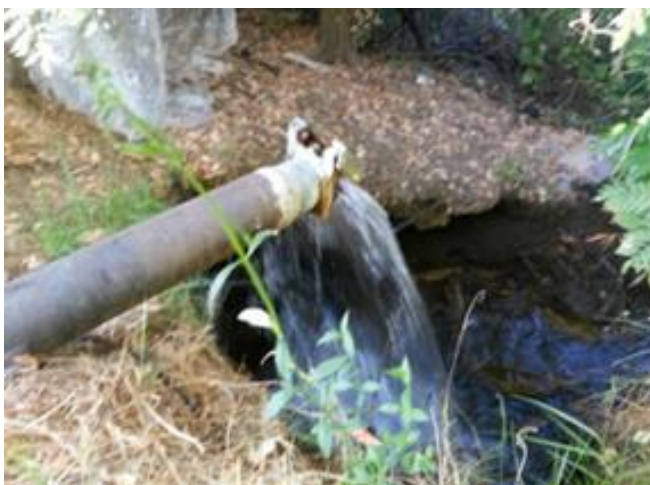
Figure 8. Inlet pump on the northeast side of Bushy Lake

The water that feeds Bushy Lake comes mostly from a groundwater well on the Cal Expo side of the levee. This water is pumped through a pipe that lets out at the east end of Bushy Lake (Figure 8). Cal Expo operates the pump to maintain the lake level in accordance with the Bushy Lake Preservation Act of 1976 (CSMSA 2008). The pumped well is not dedicated to Bushy Lake, but services other water needs of Cal Expo as well.

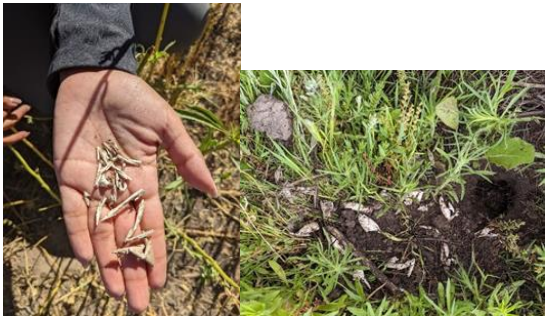
<p>Predated Nest</p>	<p>Eggshells <u>ARE</u> present. Plug <u>MAY</u> be present.</p>

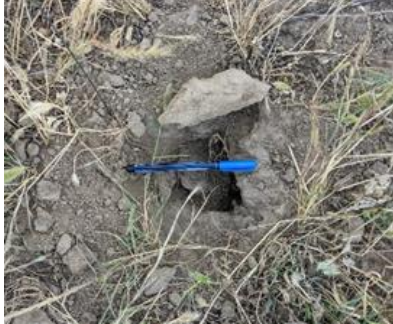
<p>Dummy Nest</p>	<p>Eggshells are <u>NOT</u> present. Plug <u>IS</u> present.</p>

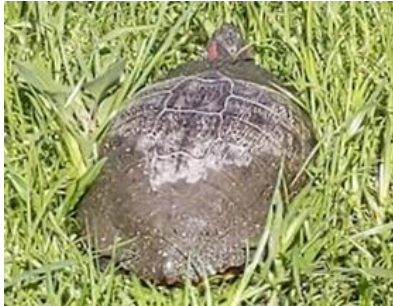
<p>Active Turtle</p>	<p>Successfully completed nest by an active turtle.</p> <p>A turtle with a muddy posterior shell indicates a nesting attempt.</p>

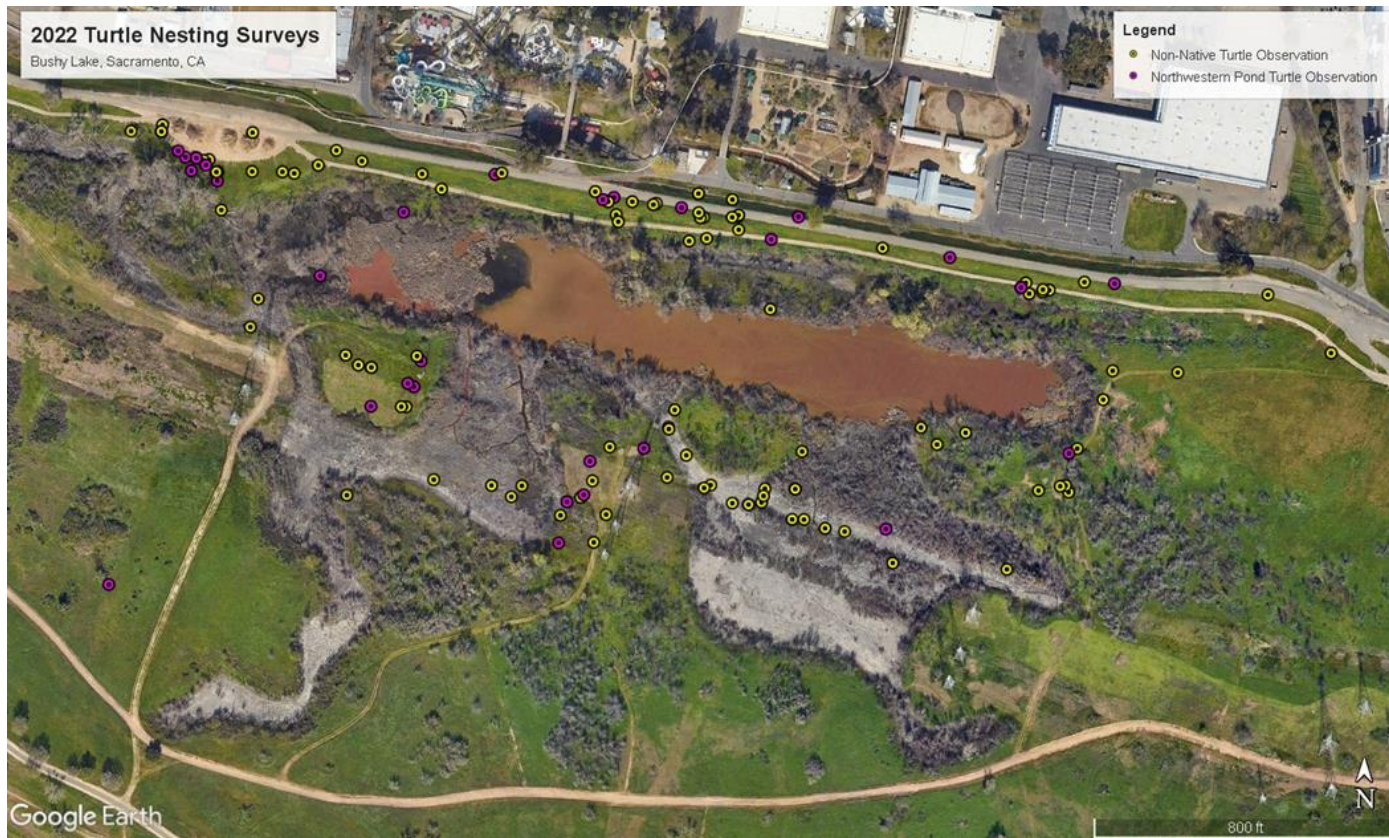
Figure 15. Nesting activity of 2022 turtle nesting surveys (April 4, May 6 – July 25, September 3 and 17, 2022)

In 2022, a total of 189 observations of nesting activity were recorded (99 predated nests [6 NWPT, 70 NNT, 23 unknown and potentially NWPT], 30 active NNT, 26 unknown dummy nests, and 32 potentially active nests [1 NNT based on shell peeling, 31 unknowns] (Table 5). The distribution of nests was more widespread in 2022 than in 2021 when there was no fire disturbance (Figure 15). The 2022 nesting survey additionally indicated the peak nesting time on June 14th (Figure 16).

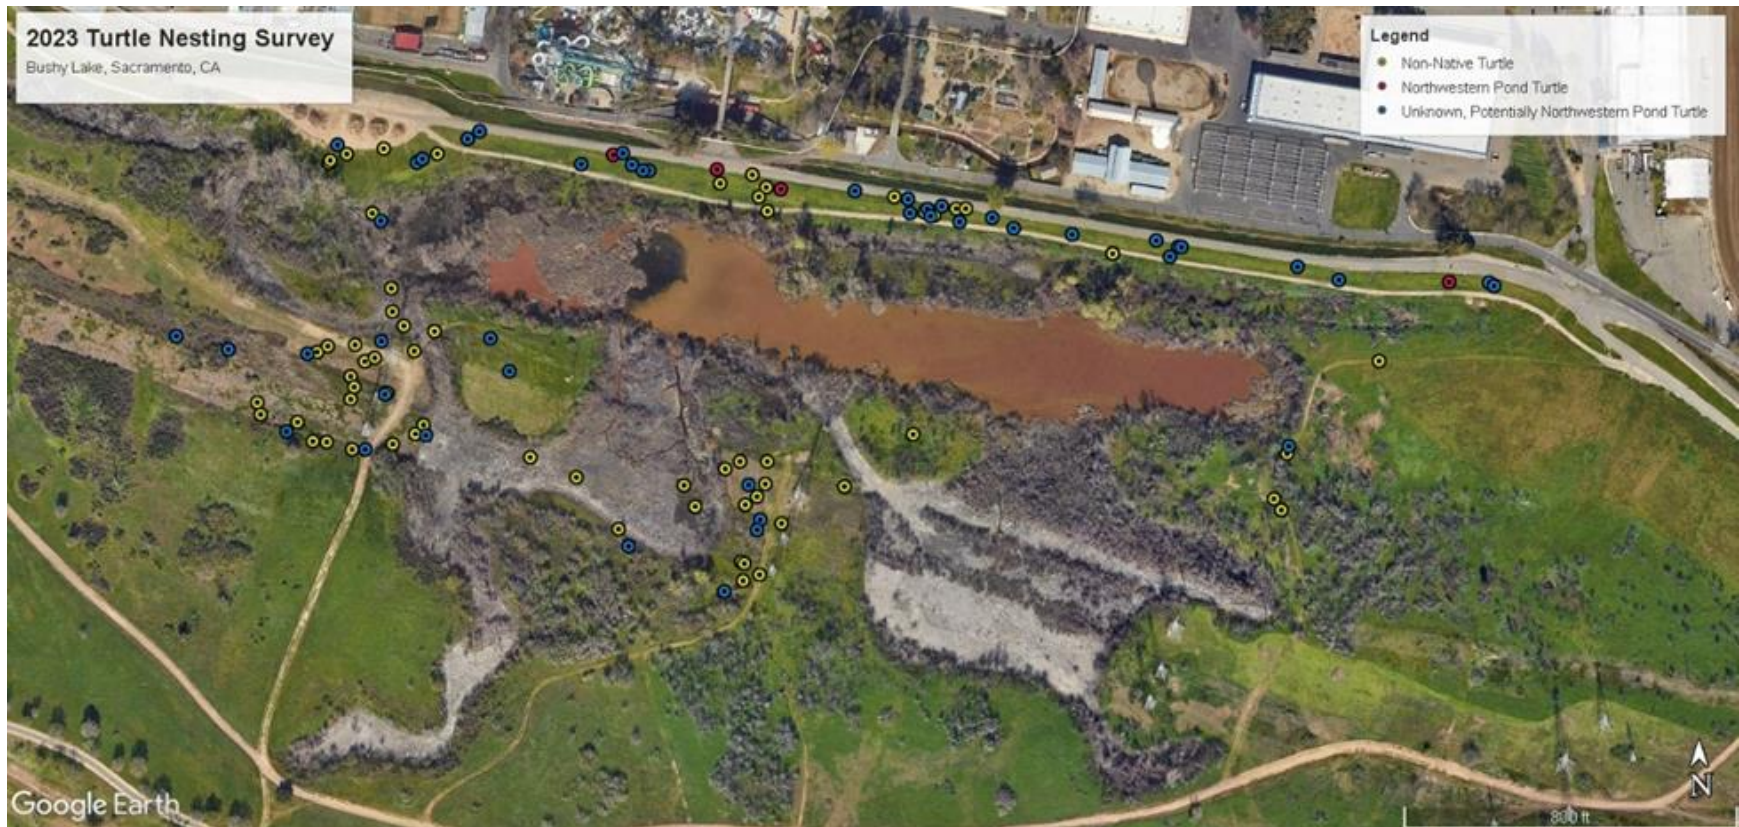
Figure 17. Nesting activity of 2023 turtle nesting surveys (May 21, May 26, June 1 – July 3, 2023)

In 2023, between June 1 and July 3, a total of 122 nesting activity observations were recorded (56 predated nests [4 NWPT, 39 NNT, and 13 unknown and potentially NWPT], 23 active NNT [1 completed nest], 37 dummy nests [6 NNT based on active turtles, 31 unknowns], and 6 potentially active and unknown nests (Table 6). Although the 2023 data featured here does not include the entire month of July, several observations can be made. Nesting activity continued to be widespread throughout the site, however, there was an increase in activity on the western side (Figure 17). Similar to the previous year's survey, activity peaked in June. June 5th had the greatest day observation count, however, there were slightly smaller peaks on June 22nd and 29th (Figure 18).

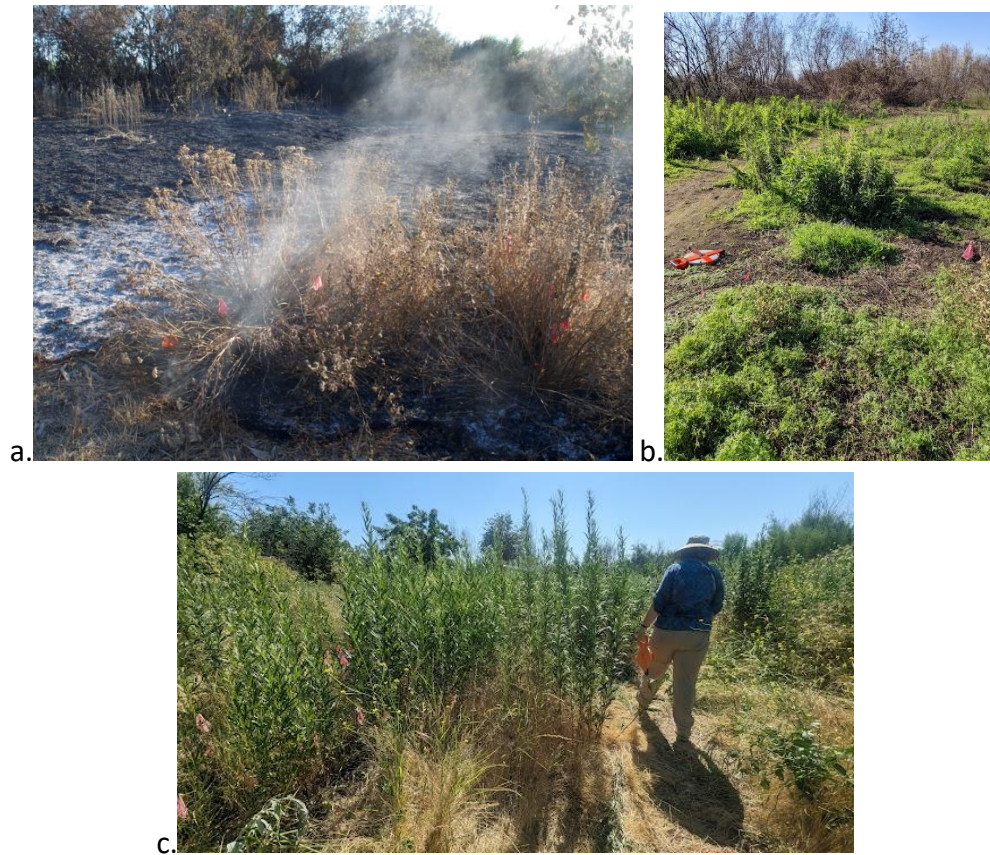
The mugwort-creeping wildrye experimental area was burned to ashes in the June 2021 fire. Today this area has also recovered after the fire, demonstrating the fire resiliency of mugwort and willow. It is also important to note that constant weeding and control of invasive species is essential to maintaining this area. Species composition, monitoring, and adaptive management are discussed in the CRP and Long-Term Management Plan.

Figure 25. Mugwort beds. The images illustrate the fire resiliency of white root immediately after the fire in a. June 2021, and post-fire recovery through natural recruitment in b. November 2021 and c. June 2023 (Photos by Gunner Michaelson and Alexandra von Ehrenkrook).

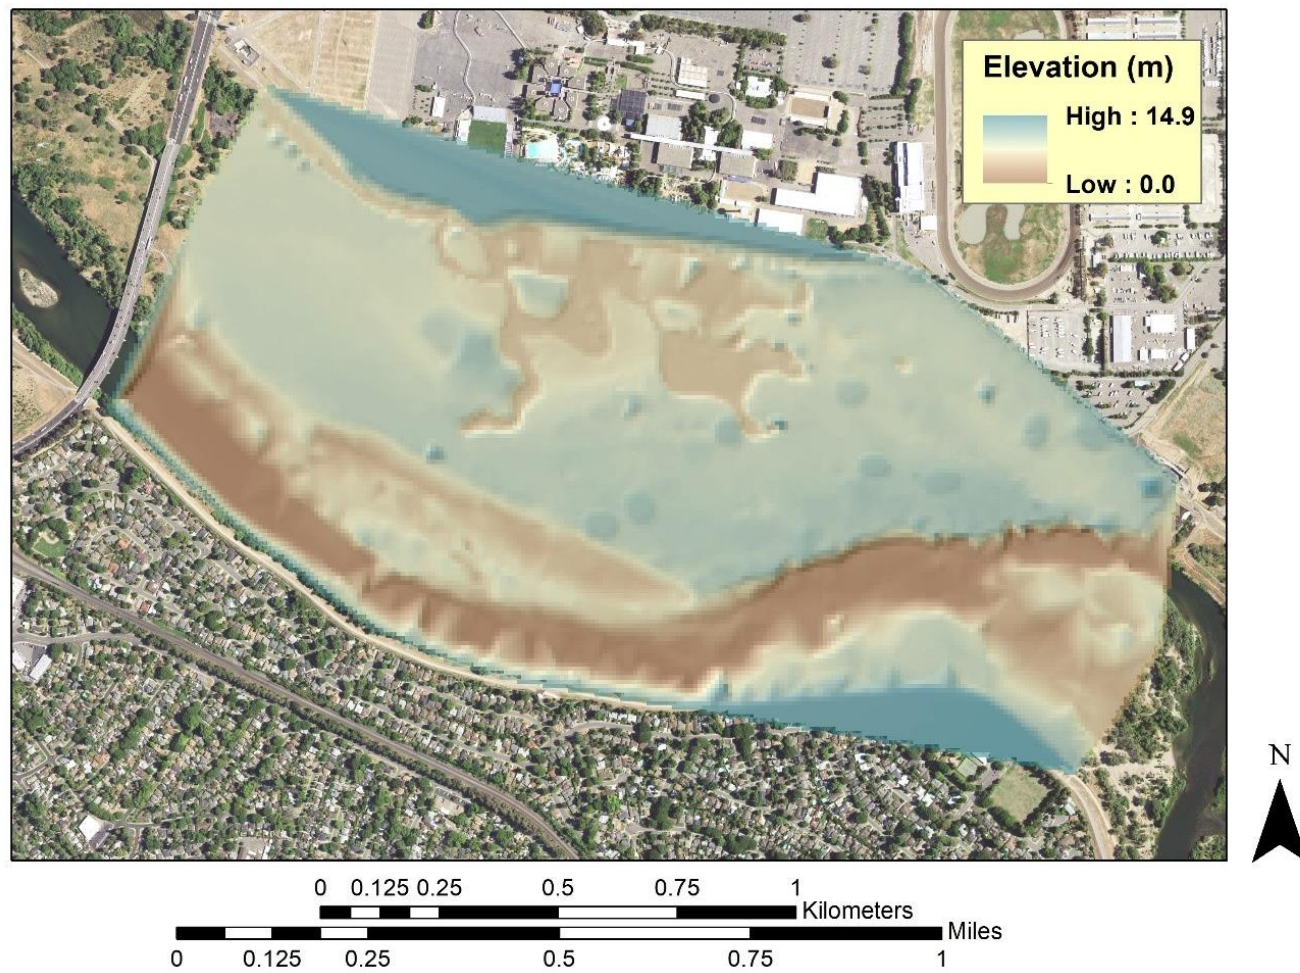
Figure 33. Digital elevation model of the floodplain remnant including Bushy Lake (light brown terrain in the middle of the map just south of Cal Expo)

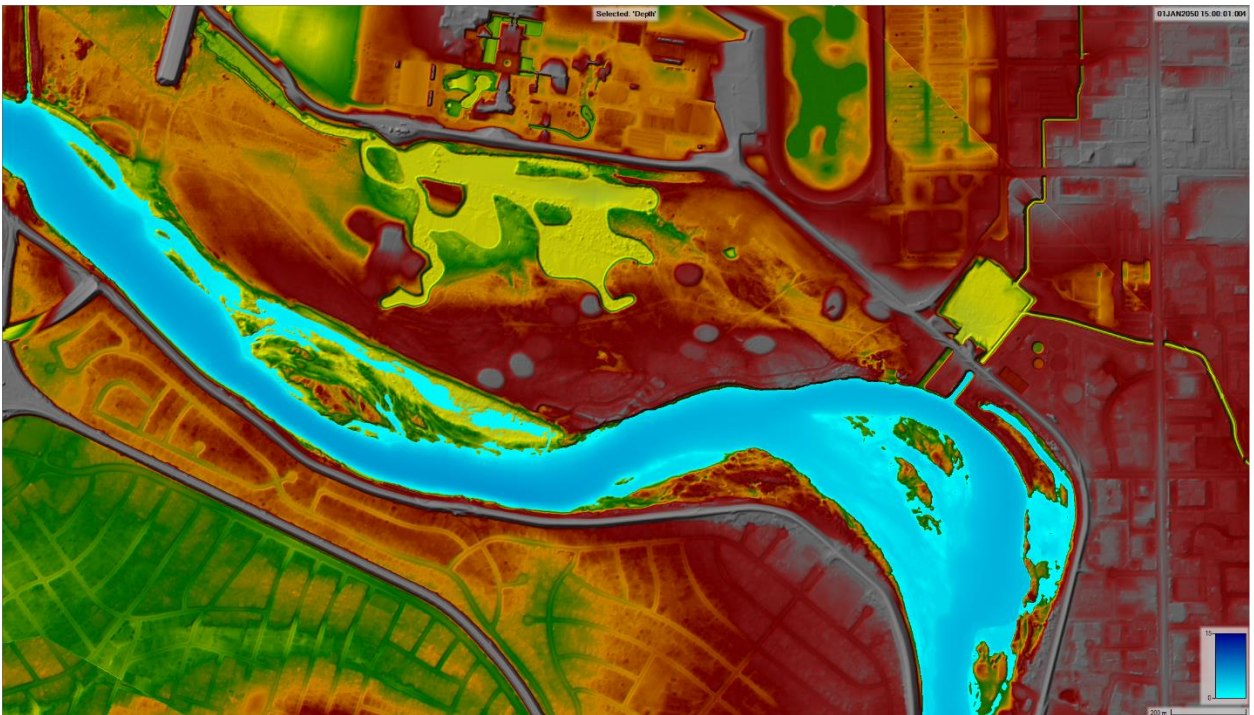
Figure 41. At 15 hours the channel has filled previously dry areas and is beginning to reach capacity.

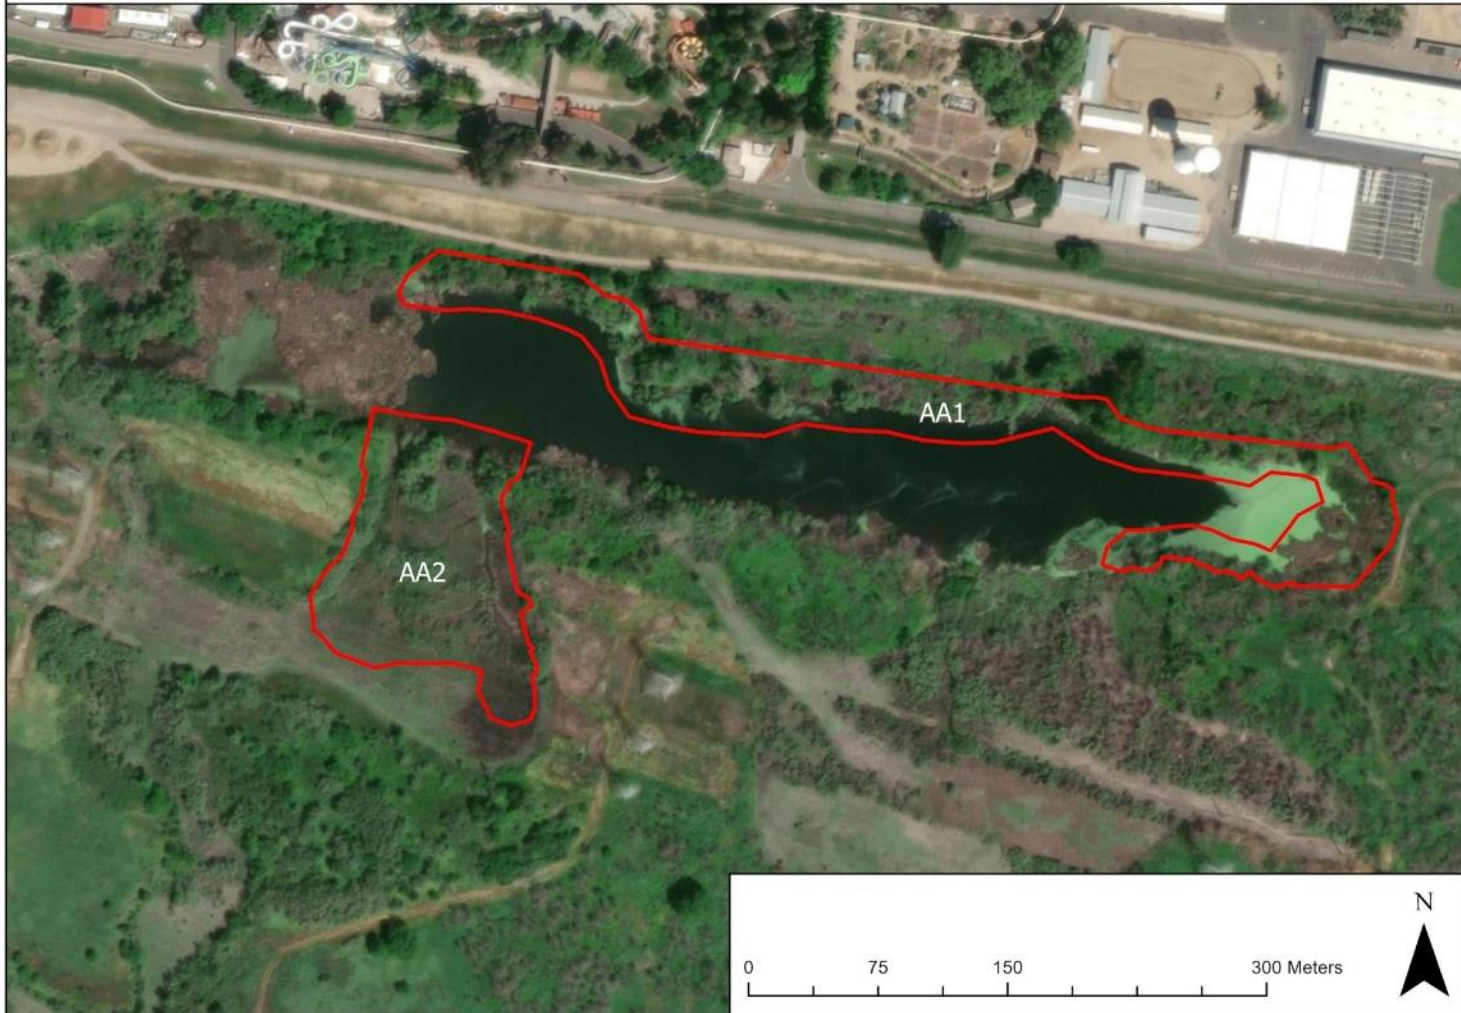
Figure 55. Assessment Areas 1 and 2 (AA1 and AA2) of the California Rapid Assessment Method (CRAM) analysis of August 2022

The expansion of aquatic habitat has been observed at Bushy Lake and is evident by California Rapid Assessment Method (CRAM) surveys. The 2022 CRAM survey identified an Assessment Area (AA) that was not present in the previous 2016 CRAM survey; this area was identified as AA2 in 2022 and developed by the creation of beaveways (Figure 49).

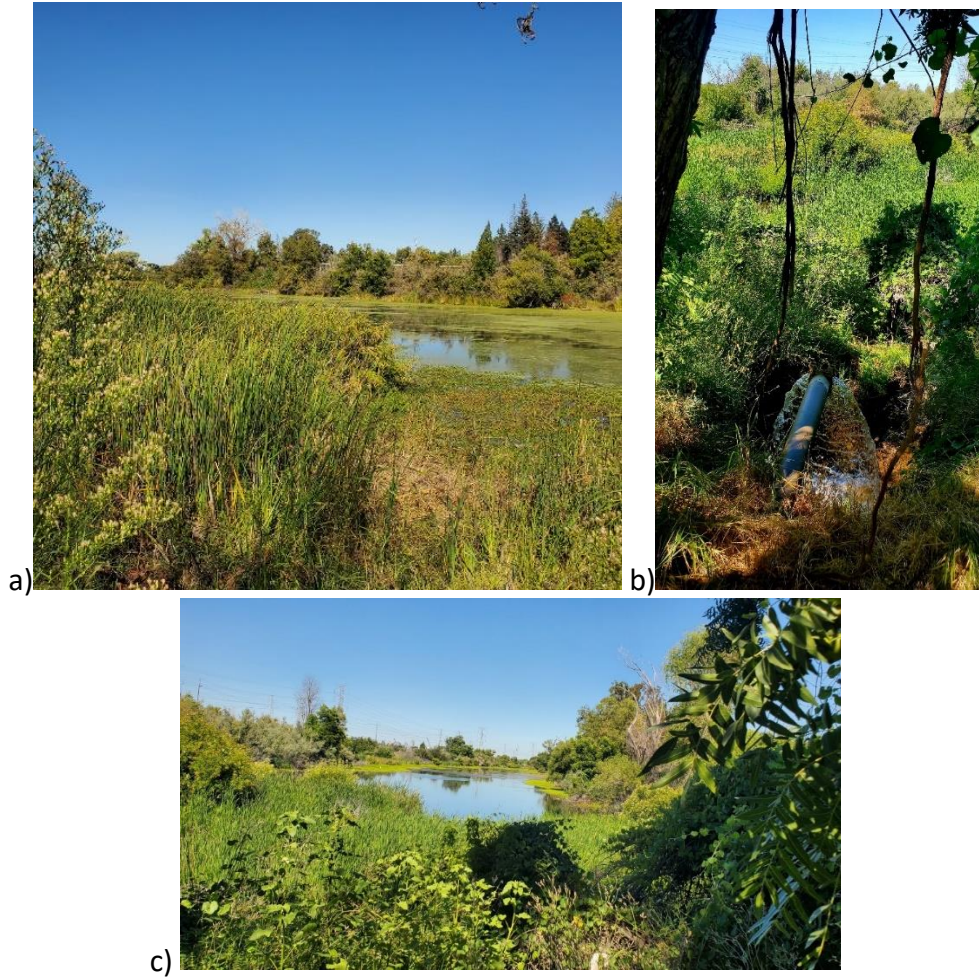
Figure 56. Assessment Area 22-1. a) northwest boundary; b) northeast featuring the water inlet through which Cal Expo pumps groundwater into Bushy Lake; c) east side

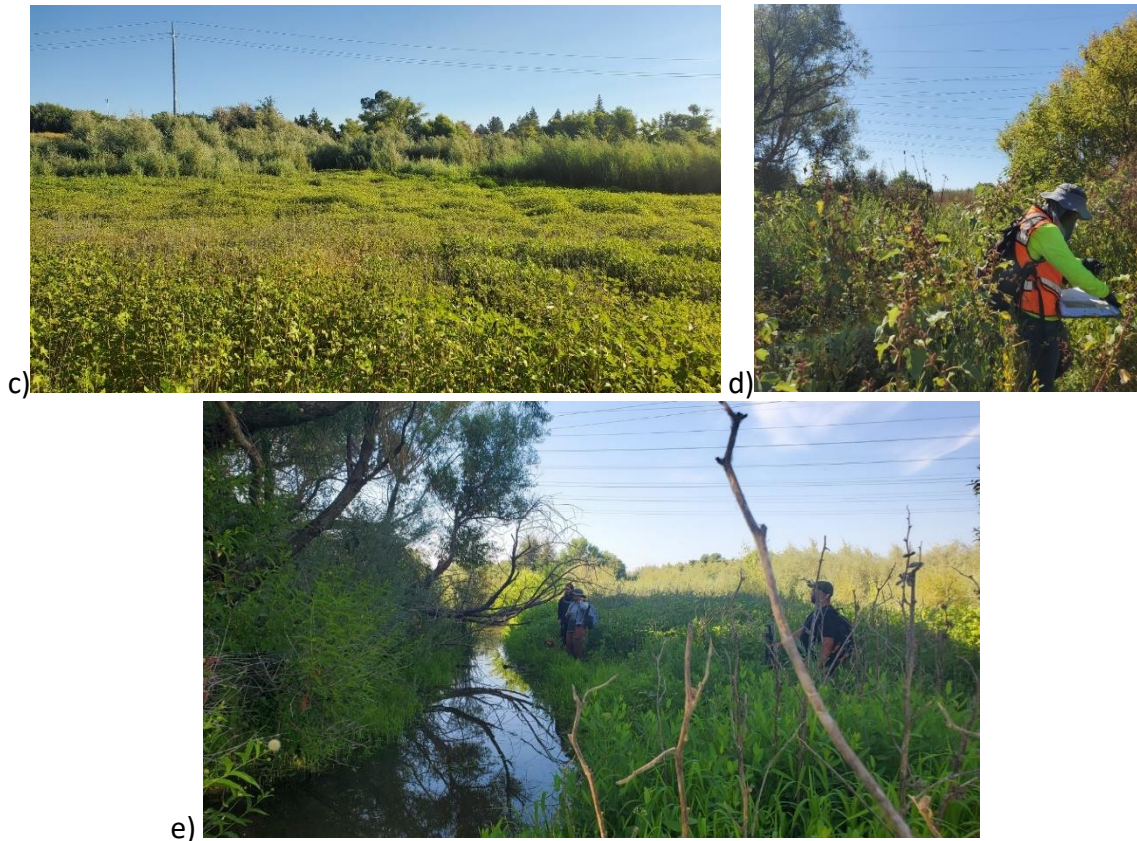
Figure 57. Assessment Area 22-2. a) west side; b) Letitia Morris along the eastern boundary, c) southern boundary, d) Justin Chappelle along the northwestern boundary, e) southwest side featuring beaver-made canals, referred to as “beaveways”, which have expanded surface water

The Assessment Area 22-2 is a newly formed seasonal wetland, so is not comparable to 16-1 and has additional wetland conditions on the site. This speaks to the importance of beavers as ecosystem engineers, contributing also to fire resiliency and habitat complexity on site.

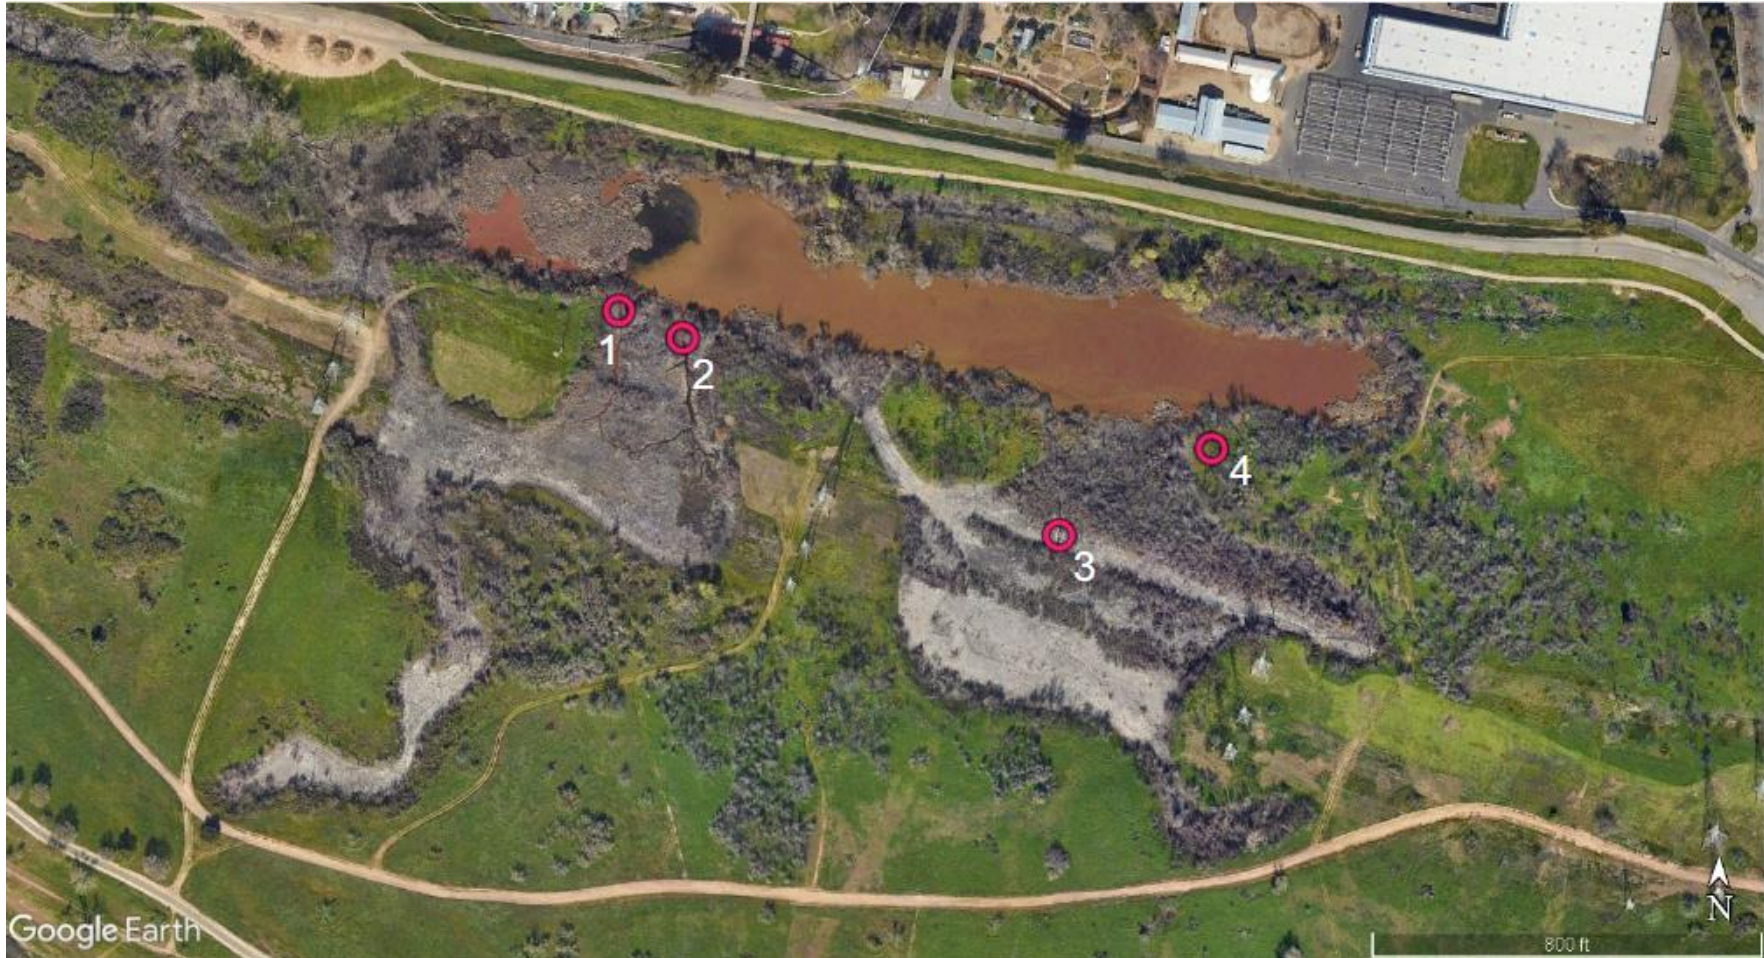
Figure 58. Wildlife camera locations at Bushy Lake (September-October 2020, September 2021-January 2022, March- November 2022, May-July 2023)

Wildlife cameras have been strategically placed in areas to best address these goals (Figure 58). Locations 1 and 2 were in the south of Bushy Lake along "beaveways" (beaver-constructed canals) with year-round standing water; cameras were placed facing upstream and downstream to identify species utilizing the canals (Figure 59). Location 3 was in the southeast of Bushy Lake along a beaveways with seasonally standing water; the cameras were placed facing the edge of a willow stand. Location 4 was in the east of Bushy Lake in the *in-situ* restoration site; cameras were placed facing the Santa barbara sedge bed to observe deer and other wildlife utilizing the area. The camera locations were adjusted to reflect site conditions, however, the cameras remained in the same general areas. Unhoused individuals moving or damaging cameras
