Bushy Lake 2022 Summary Report

California Wildlife Conservation Board Grant Agreement for Bushy Lake Conceptual Restoration Plan WC-1943CA
Data Contributing to Critical Elements for Western Pond Turtle Habitat

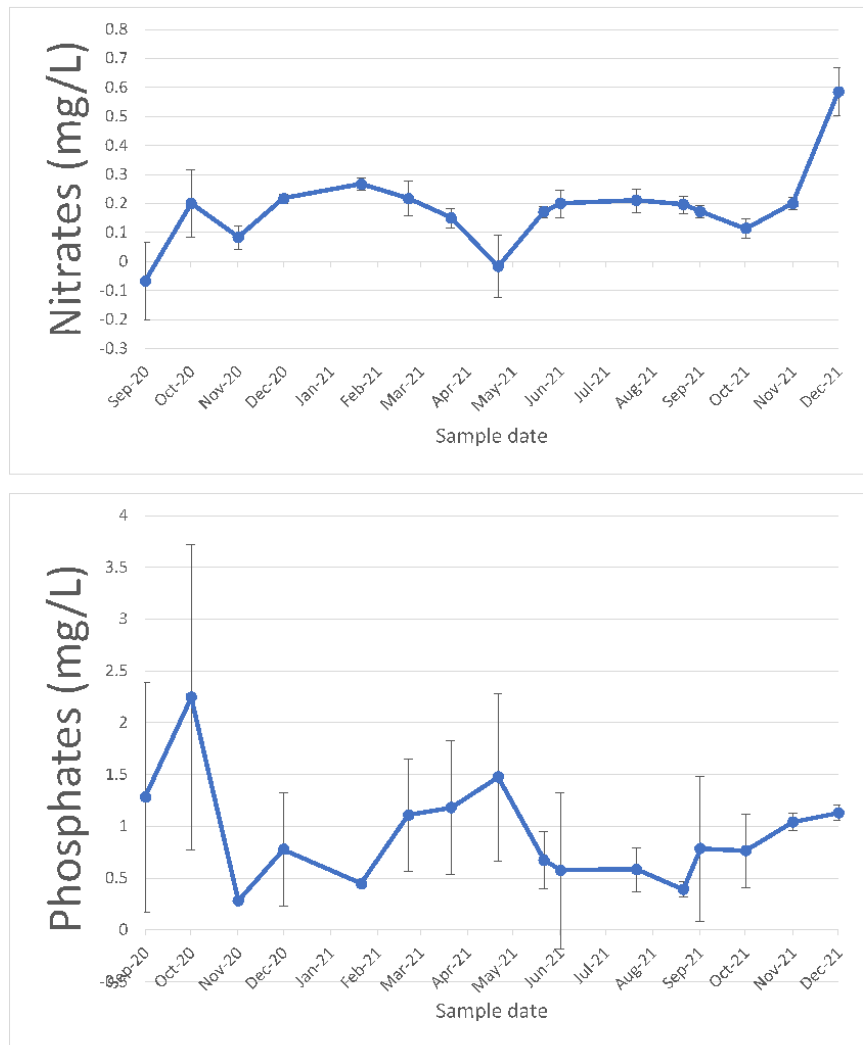
Figure 13. Monthly measurements of nitrates and phosphates in Bushy Lake from Sept 2020 until December 2021. Values represent the mean (\pm SE) of six sites sampled per month.

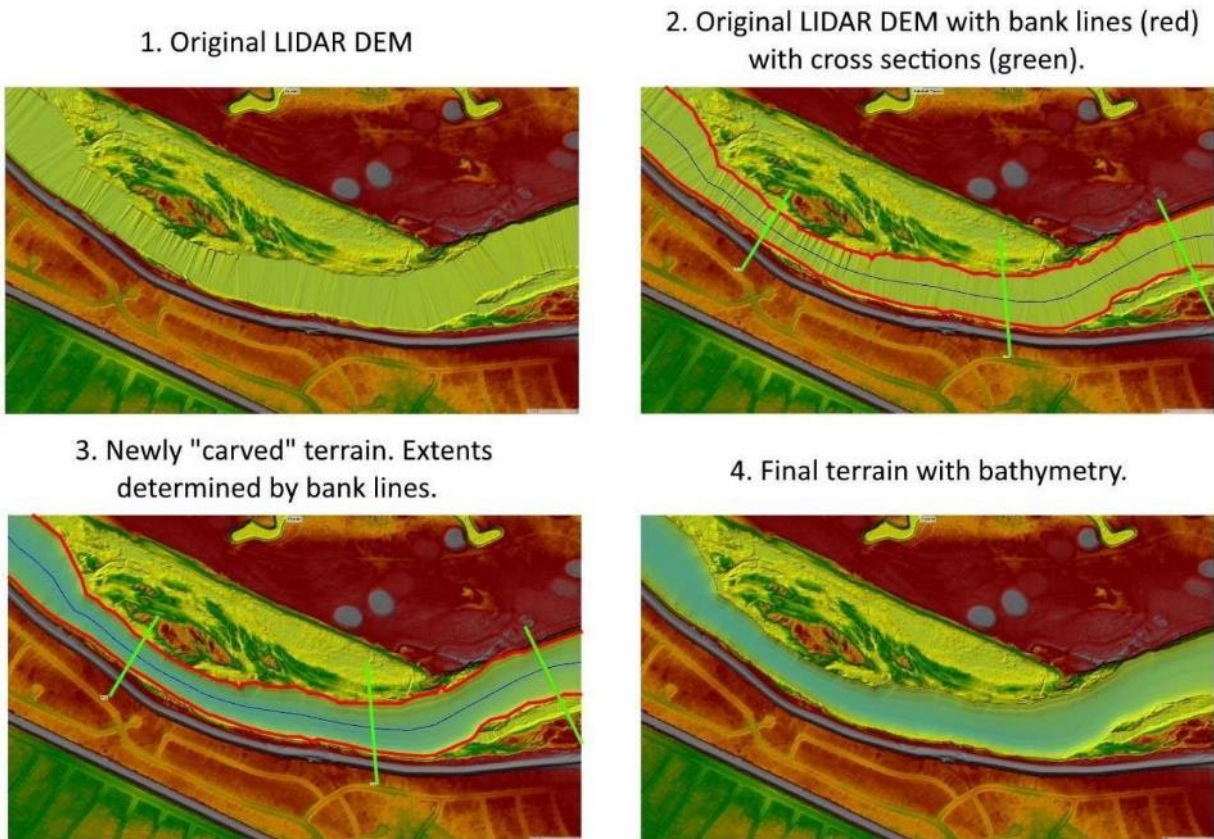
Figure 25. Adding bathymetry to LIDAR DEM within HEC-RAS using a 1D geometry to edit a 2D terrain.

To add bathymetric data to the American River, survey data was incorporated into the digital elevation model. Survey data was collected using a Trimble Geo 7x. Survey points were manually taken by walking and placing the Trimble unit. The Trimble unit is capable of recording location to an accuracy of 2 cm. Using ArcMap, the interpolated river bathymetry was cut from the survey data. Within HEC-RAS, the bathymetry was layered over the LIDAR data set. This led to a data set that was a good estimation of river bathymetry in some areas of the river reach but was missing data where we were unable to physically reach/wade while surveying. To obtain a complete terrain model with bathymetry, a 1D geometry can be used to edit 2D terrains within HEC-RAS. Editing 2D terrains with 1D geometries require the creation of two distinct objects. These consist of cross-sections and bank lines. The first step in the process is to create multiple cross-sections across the river surface in RAS Mapper from left to right downstream (see figure 2). Then bank lines are drawn to define where the river surface meets the ground of the elevation model. To edit the 2D terrain the cross-sections were manually adjusted to conform to the observed bathymetry from surveying. The new cross-sections are then essentially used to “carve” out the 2D terrain. The bank lines are used to determine the extents to which the channel is carved.

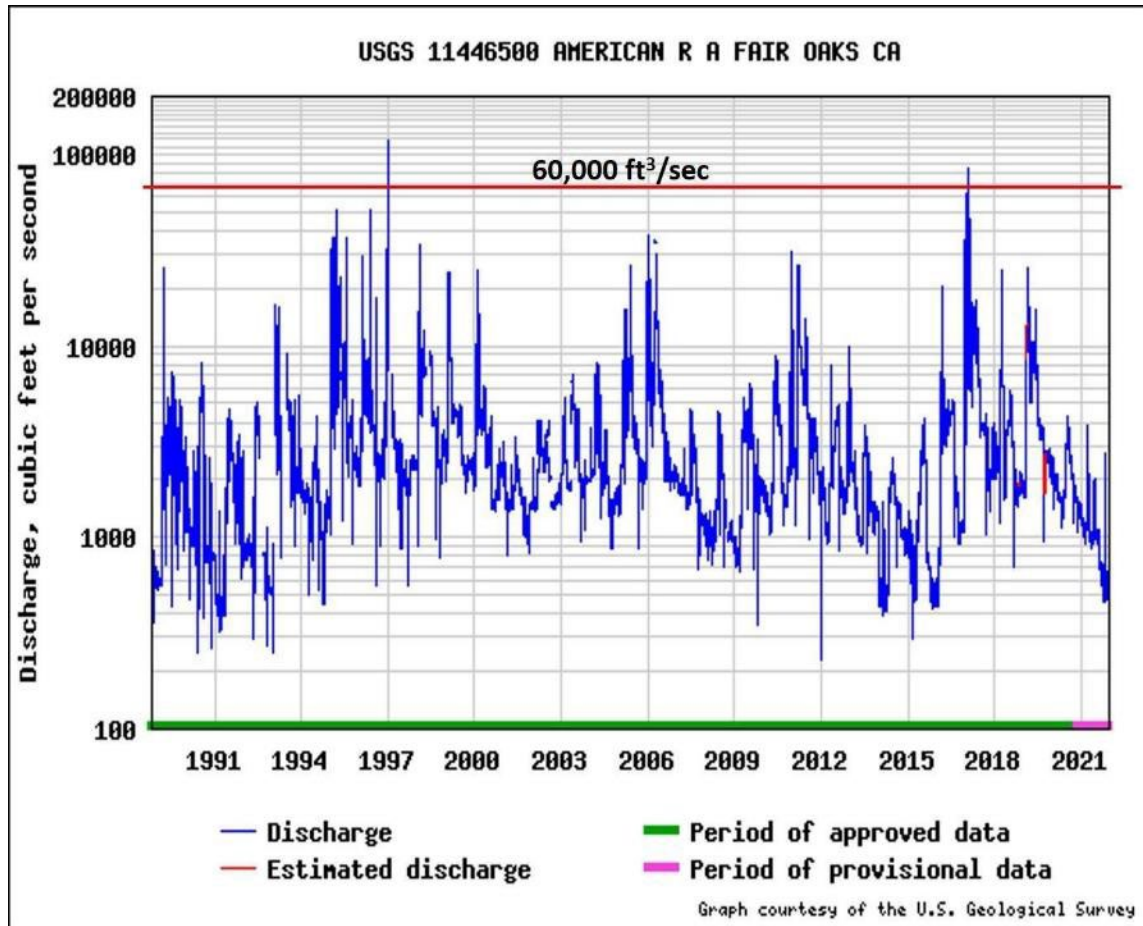
Figure 41. Fair Oaks gauge reading for discharge (1989-2021). In 1997 and 2017 flows of over 60,000 CFS occurred (red horizontal line) and likely flooded the area of Bushy Lake. Numerous events on the order of 20,000-30,000 CFS occur, but would be confined to the river channel.
